#### Experiences and discussion topics in Germany

Hermann Laukamp, Jerome Tschupp (Fraunhofer ISE), Björn Maiworm, Horst Thiem (Munich fire department), Anett Sepanski, Florian Reil (TÜV Rheinland), Helmut Godard (Energossa), Ralf Haselhuhn (DGS)

Fire Asia 2018, May 7, 2018 – May 9, 2018 Hongkong

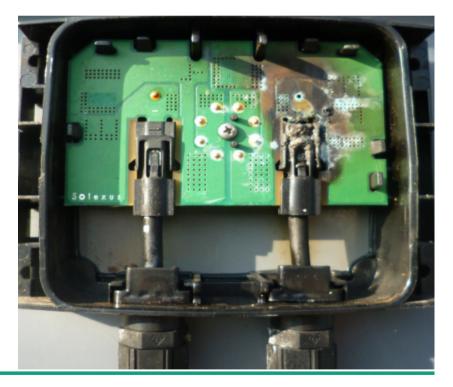
#### **Production flaws or poor quality**

components – modules - module junction box

systematic fault in junction box caused several

fires in France,

> 100 000 modules concerned

rather high property loss due to roof integrated systems due to government incentives

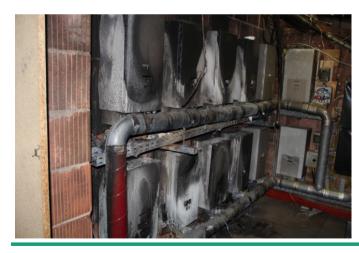
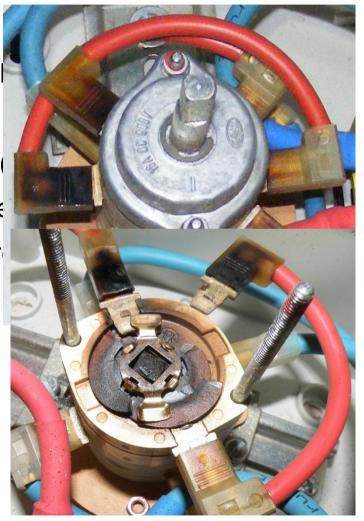
DC disconnect swithc combination of stress influences caused fail

source of fire was a DC switch

inverter room in the attic – heat from the

many inverters tightly mounted - more he

small room – poor ventilation – even mor

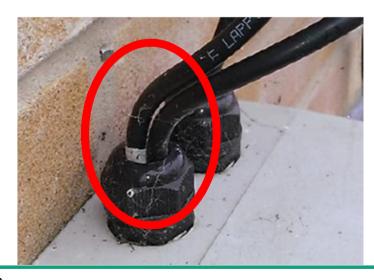
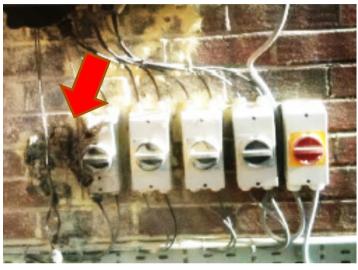
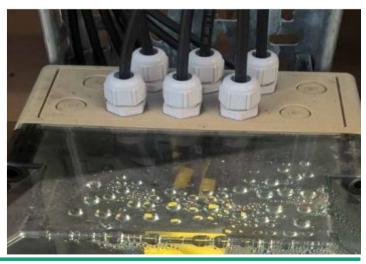
UK investigation: main fault location; DC disconnector

- 9 out of 15 cases installation fault
  - 5 x water ingress
  - weak point: cable gland on top of housing exposed to weather (no drainage?)

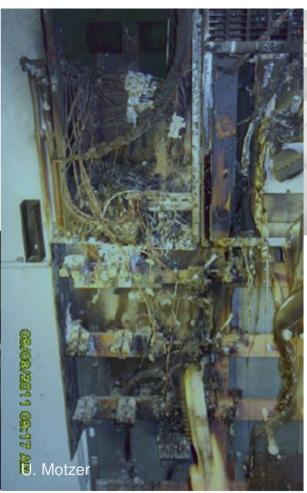
regular AC side components fail unexpectedly often

- fuses
- terminals/cables
- aluminum conductors!

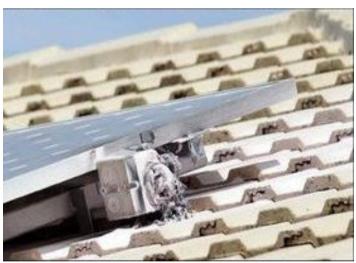
- Australia, end 2012: normative requirement for a "Rooftop DC Isolator Switch" to enhance firefighter safety
- until November 2014 → more than 200 fires because of "Rooftop Switch" only in Queensland state with about 400 000 Systems

- -> immature products without proper specification and type testing
- => avoid hastily introduction of components without proven product standard
