#### Experiences and discussion topics in Germany

Hermann Laukamp, Jerome Tschupp (Fraunhofer ISE), Björn Maiworm, Horst Thiem (Munich fire department), Anett Sepanski, Florian Reil (TÜV Rheinland), Helmut Godard (Energossa), Ralf Haselhuhn (DGS)

Fire Asia 2018, May 7, 2018 – May 9, 2018 Hongkong

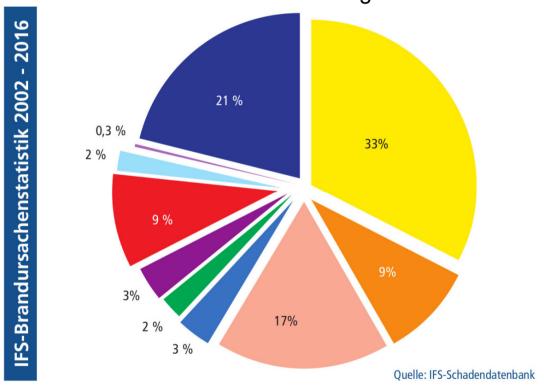
Statistical evaluation of electricity triggered fires in Germany (from "institute for loss prevention and loss research" of an insurance company group) based on some 15 000 fire investigations

Electricity is predominant cause of fire

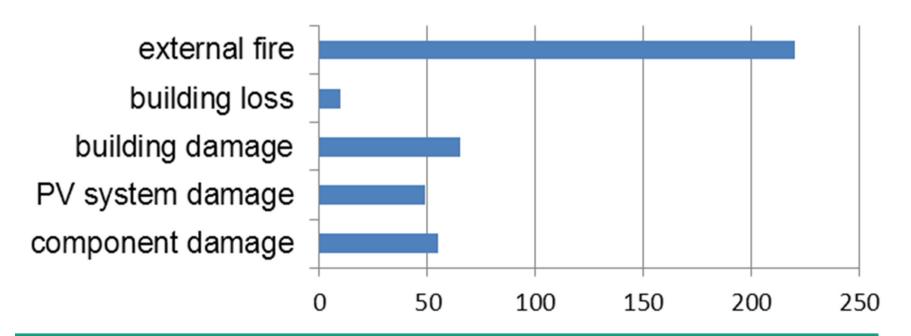
severity of damage - impact on surrounding

data basis: some 180 cases of fire damage and overheating

some 220 cases of PV damaged by external fire

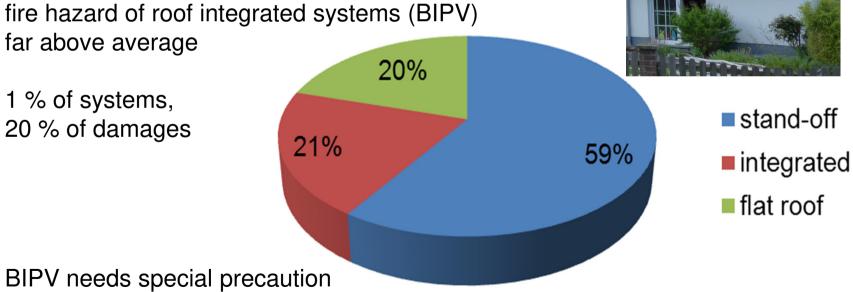
building damage risk strongly depends on mounting type

cases of damaged buildings only (63 cases)

stand-off systems protected by "hard roofs" (tiles)

fire hazard of roof integrated systems (BIPV)

far above average

1 % of systems, 20 % of damages

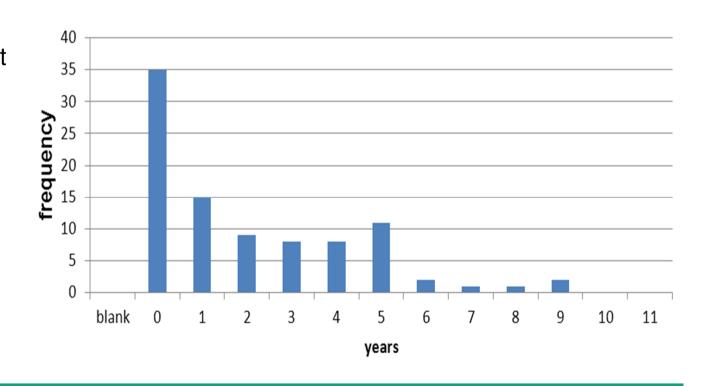
#### age of system at damage event

most incidents occured during installation or first year of operation

probably many installation flaws

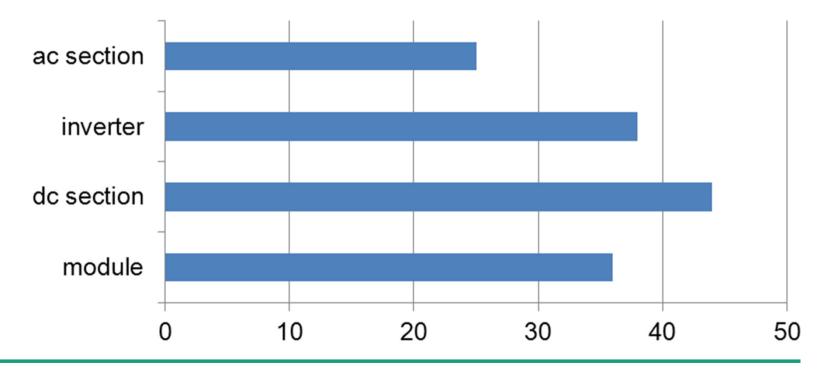
#### location of incident – source of damage

ac side nearly as often as dc side

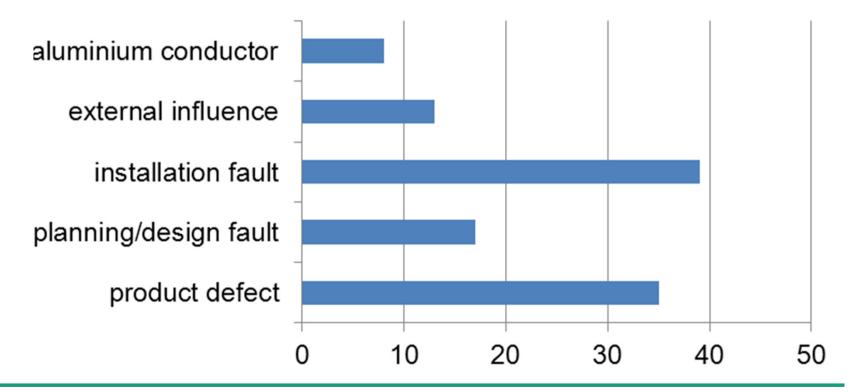
#### main root cause of damage

(inappropriate use of aluminium cable is included in installation faults)

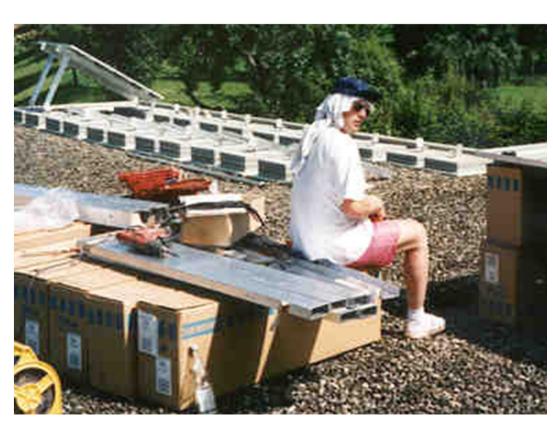
# causes of installation faults

often ignorance and sloppiness

but also tough working conditions

- time pressure
- exposure on roofs
- heat, hot surfaces, "burning" and glazing sun

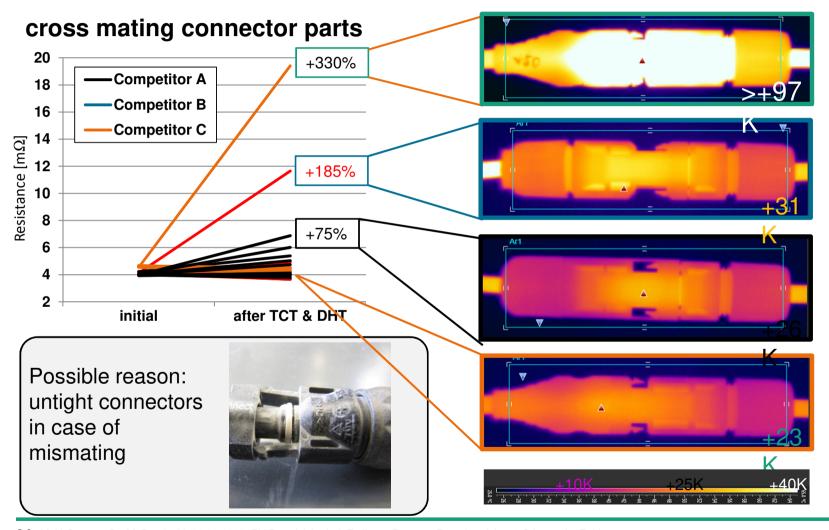
26 Multi-Contact, Dr. M. Berginski, 24.01.2013, PV-Brandsicherheit Freiburg: Paarung Fremdprodukte & Crimpen im Feld
